Manhole Inspection Summary

Manhole # S35EE1022MH

Insp Date: 1/31/07 2:12 PM

Location Address: **3815 FENCHURCH ROAD**

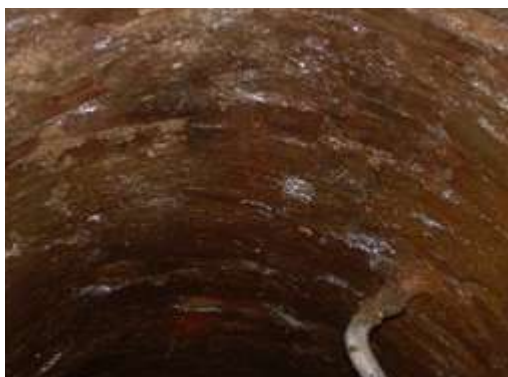
Defect

Infiltration: ☐ None ☐ Joint ☐ Cracks ☐ Mortar ☐ Roots ☒ **Wall**

INFILTRATION MH

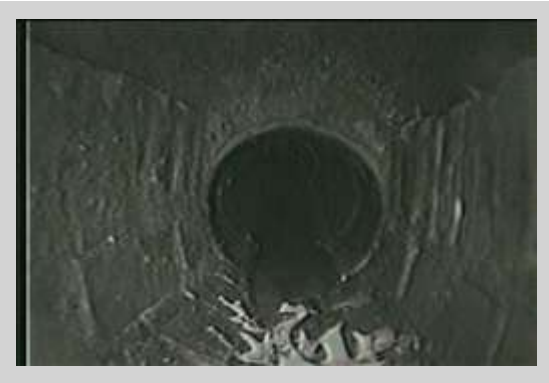
8 in. Circular Gravity Sewer Pipe Out @ 12 O'Clock

Invert Depth: **10.88** (ft.) Flow Characteristics: **Slow**

Deposits: ☐ None ☐ Mud ☐ Sludge ☒ **Debris** ☐ Grease

Silt Depth: (in.) Deposits Extent: **Light**

Infiltration: **None** Pipe Seal Cond: **Sound**

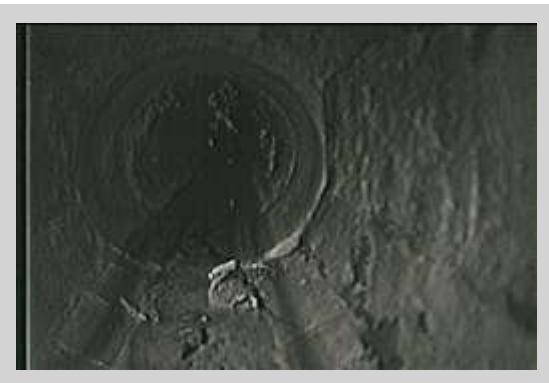
8 in. Circular Gravity Sewer Pipe In @ 6 O'Clock

Invert Depth: **10.53** (ft.) Flow Characteristics: **Slow**

Deposits: ☒ **None** ☐ Mud ☐ Sludge ☐ Debris ☐ Grease

Infiltration: **None** Pipe Seal Cond: **Sound**
